# Morris Air Seeder--Chickpea Seeding

Morris provided an air cart/air delivery system to determine operating parameters that will minimize chickpea damage.

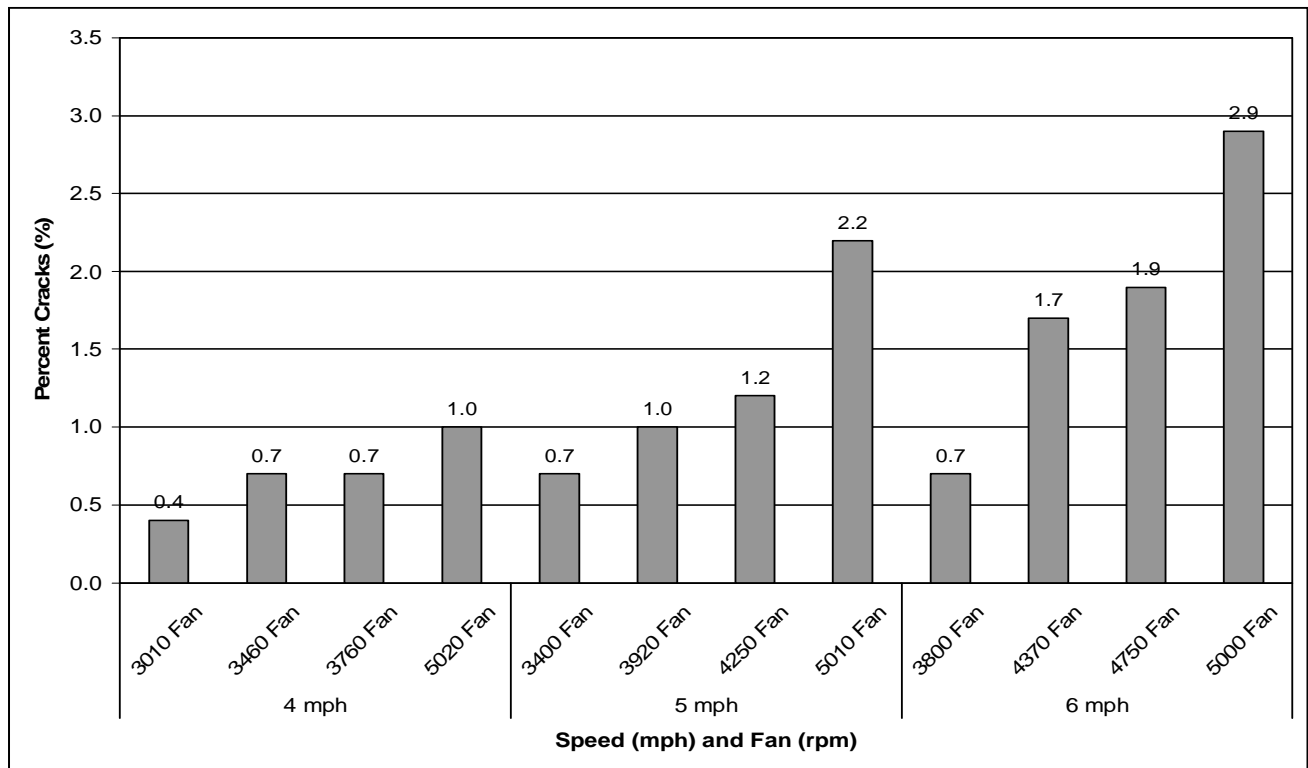
**Figure 1.** Effect of the Morris Ground and Fan Speed on Chickpea Damage.

Chickpea damage with the Morris system was very low at all tested fan speeds (**Figure 1**).

The base fan speed would only likely be used in ideal conditions. The base fan speed, plus 25%, would be a more typical operating fan speed for field conditions. Although seed damage increased at higher fan speeds, even at maximum fan speed total seed damage was less than 3%.

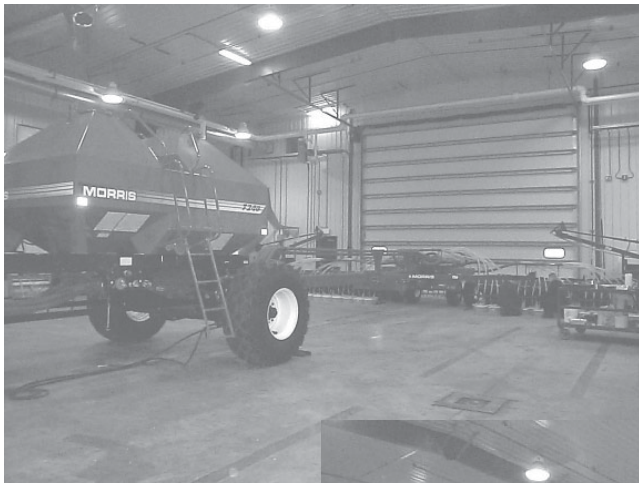
*Setting up the test.*

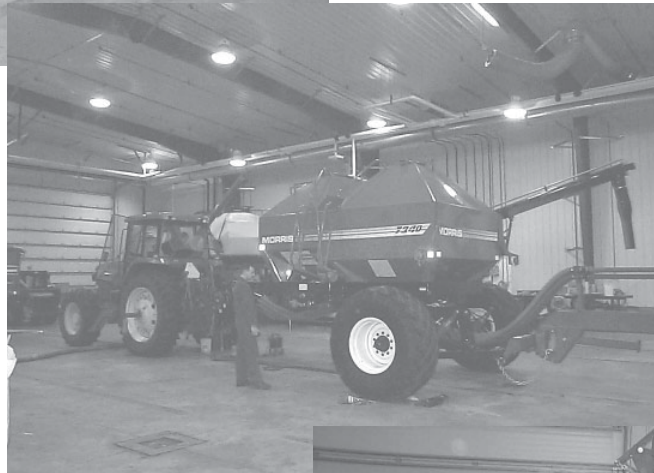
*Setting mph and rpm.*

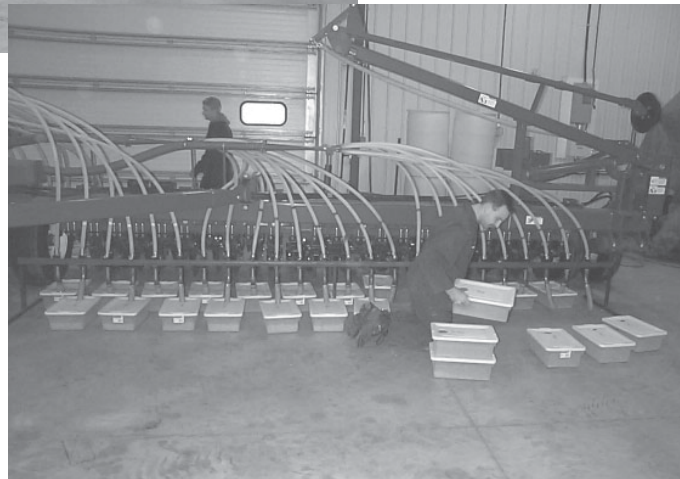
*Collecting the test results.*
